WHY CLOSE TOLERANCES ARE NECESSARY
UNDER HIGH-VELOCITY FLOW

Hydraulic Laboratory Report No. Hyd-473

DIVISION OF ENGINEERING LABORATORIES

October 20, 1960

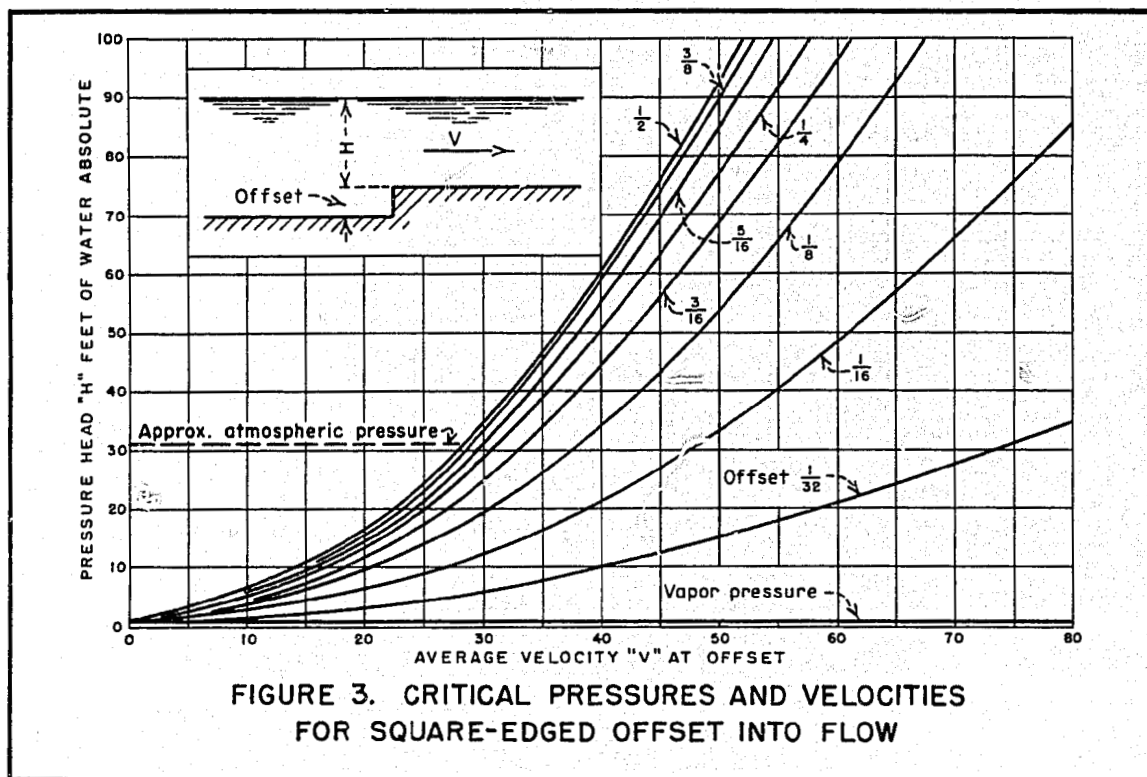
FIGURE 3. CRITICAL PRESSURES AND VELOCITIES
FOR SQUARE-EDGED OFFSET INTO FLOW

The first, and one of the most common, will be the offset joint. The joint may be offset either into or away from the flow (Figures 2A and 2B). The offset into the flow has the greater cavitation potential and also has the bad feature of subjecting the joint to extremely high pressures due to impact on the upstream face of the offset. Laboratory studies have established the velocity-pressure relationship for incipient cavitation for different sizes of square-edged offsets into the flow (Figure 3). With a known velocity and a known pressure, it is possible to determine the size of offset that can be tolerated. A field example of damage resulting from this type of offset is shown on Figure 4. The offset was in the concrete wall downstream from one of the outlet gates at Palisades Dam where the pressure in the water at the irregularity was nearly atmospheric. The velocity of the water was about 100 feet per second and the offset was about 1/8 inch. The chart of Figure 3 does not extend beyond velocities of 80 feet per second, but nevertheless definitely shows that cavitation will occur and that the damage should be expected. Rounding the corner will decrease the cavitation potential of the irregularity, but the influence is not known at this time.

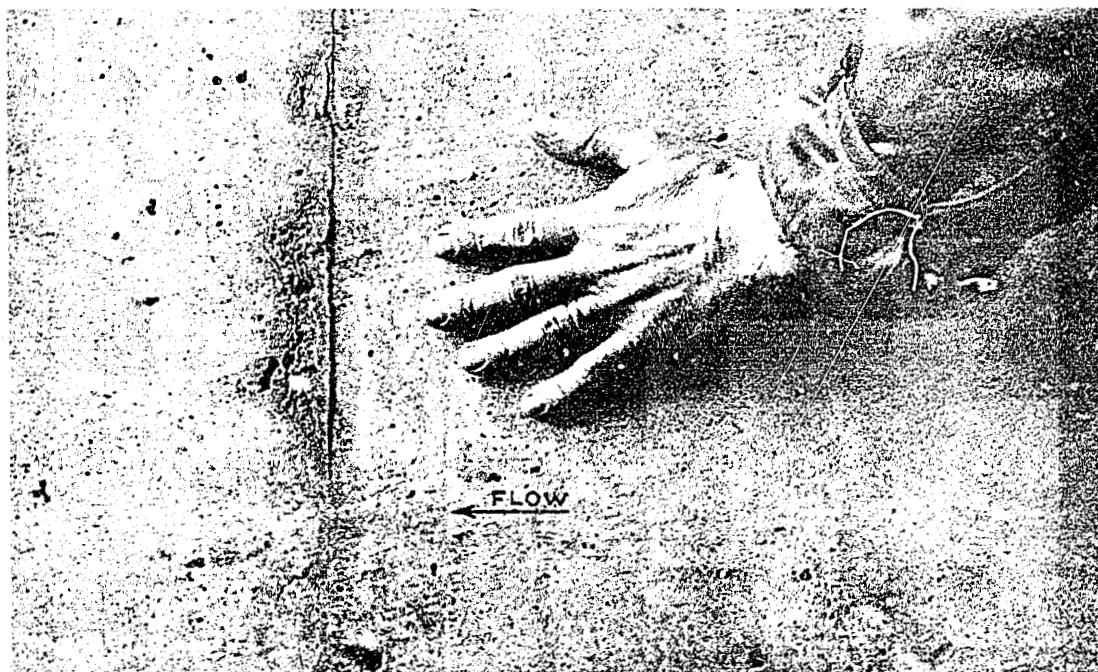
Figure 4--Cavitation-erosion downstream from $\frac{1}{8}$ inch into-the-flow offset, atmospheric fluid pressure, and velocity of 100 feet per second--Palisades Dam Outlet Works.

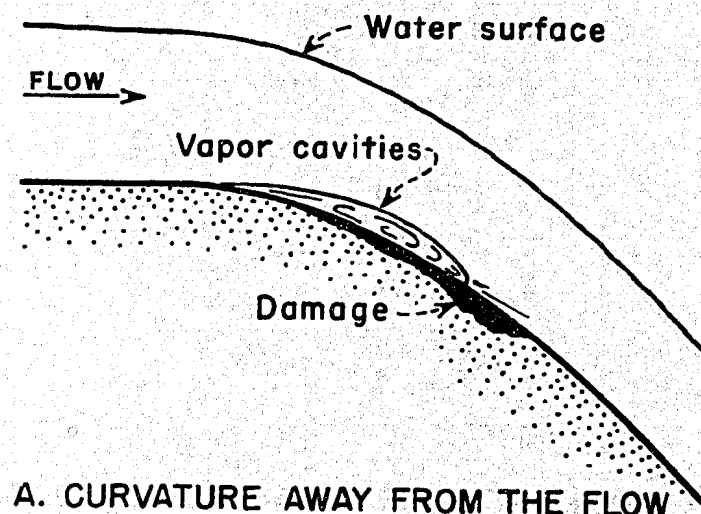
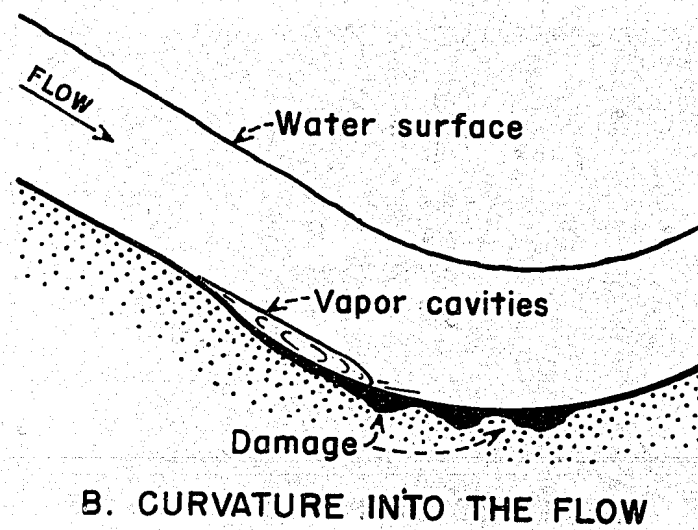
FIGURE 5. CAVITATION ON
CURVED SURFACES

Actually cavitation damage may reach a stable condition or may progress to reach extensive proportions, Figure 5. In cases where the surface curvature is away from the flow cavitation damage will, where the curvature is just right (Figure 5A), reach a point where recirculation occurs. This raises the pressure above the vapor pressure and cavitation ceases.

In cases where surfaces encroach upon the flowing stream (Figure 5B), the cavitation will be progressive causing extensive damage. Unfortunately most cases are of a progressive nature.

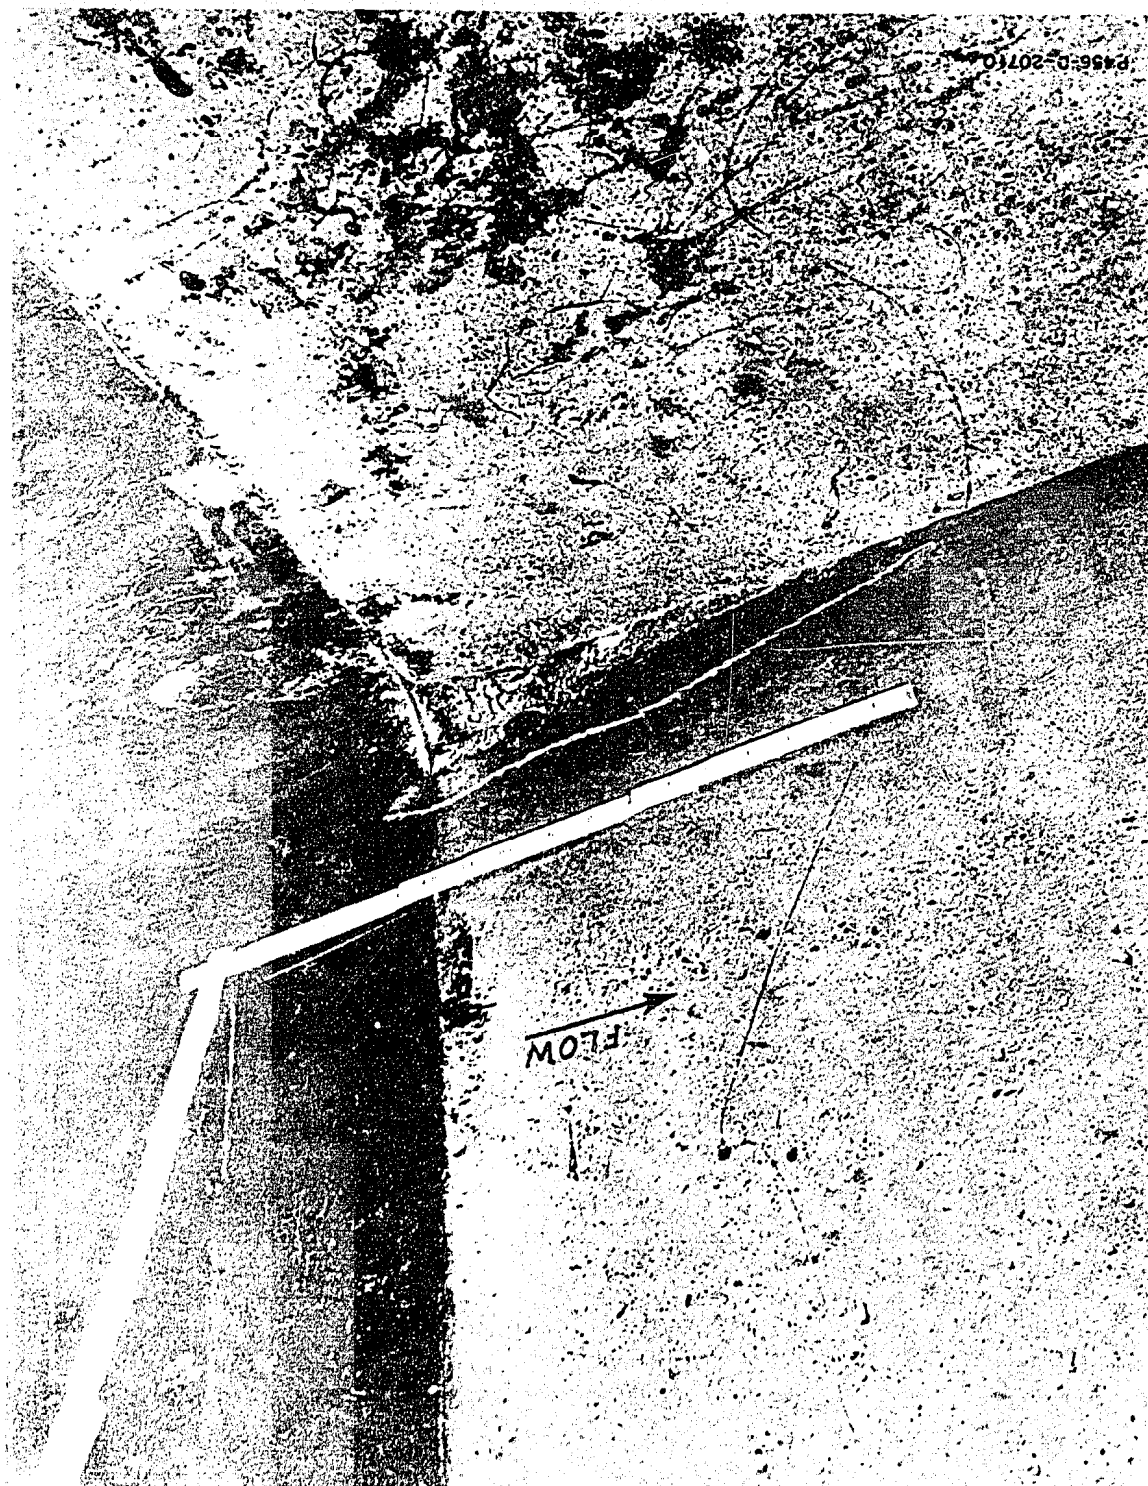
Figure 6--Slight cavitation-erosion, slope away from flow at fillet downstream from outlet gate frame--Palisades Dam.

This type of alinement change (Figure 6) was the cause of considerable damage downstream from one of the gates at Palisades Dam (Figure 7). The slope change occurred at a corner immediately downstream from the gate frame where a concrete fillet about 10 inches long sloped outward from the curve of the metal to the sharp corner in the concrete. The eroded area was several feet long, about 2 feet wide with a maximum depth of 7 inches. The irregularity was of the type shown in Figure 1D. Repair was made in such a way that the rate of slope change was sufficiently gradual to prevent pressures of vapor pressure magnitude.

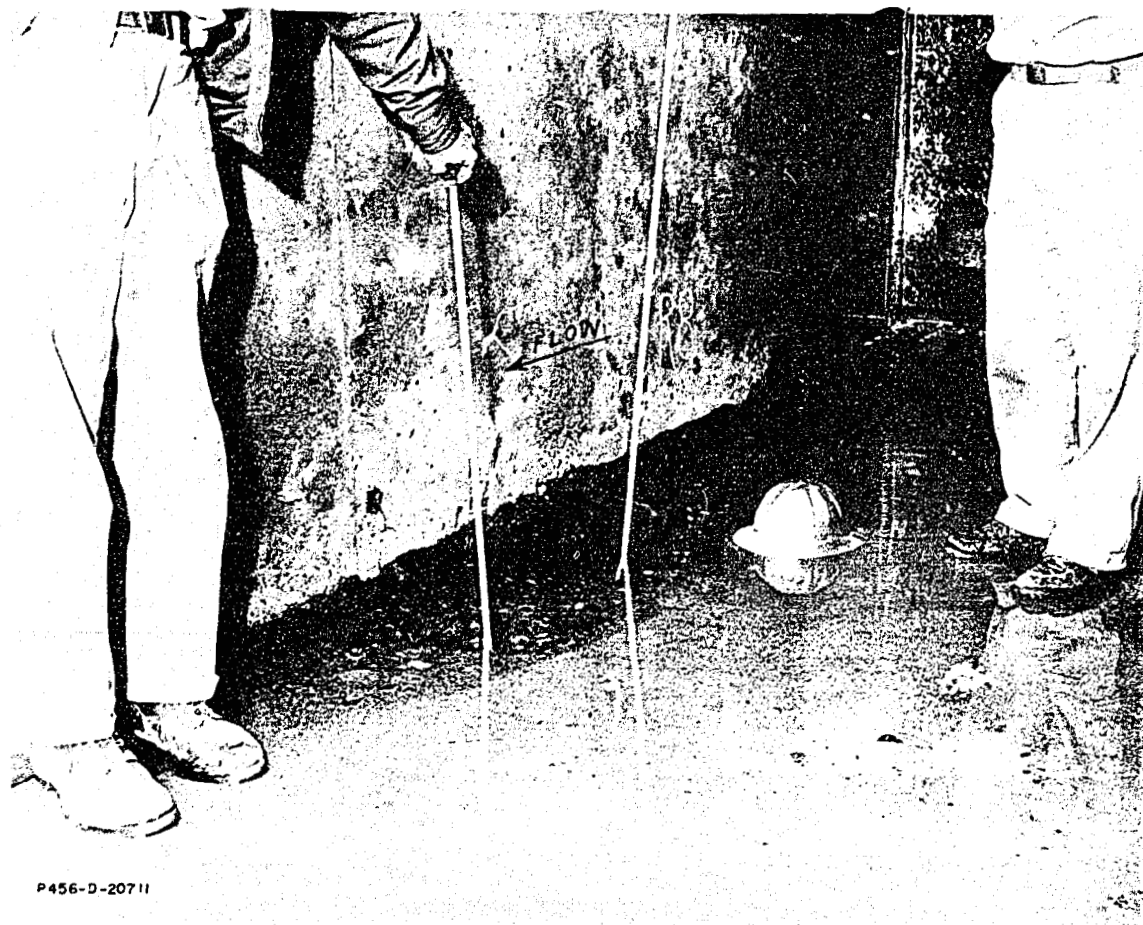
Figure 7--Progressive cavitation-erosion caused by slope away from flow at fillet downstream from outlet gate frame--Palisades Dam.

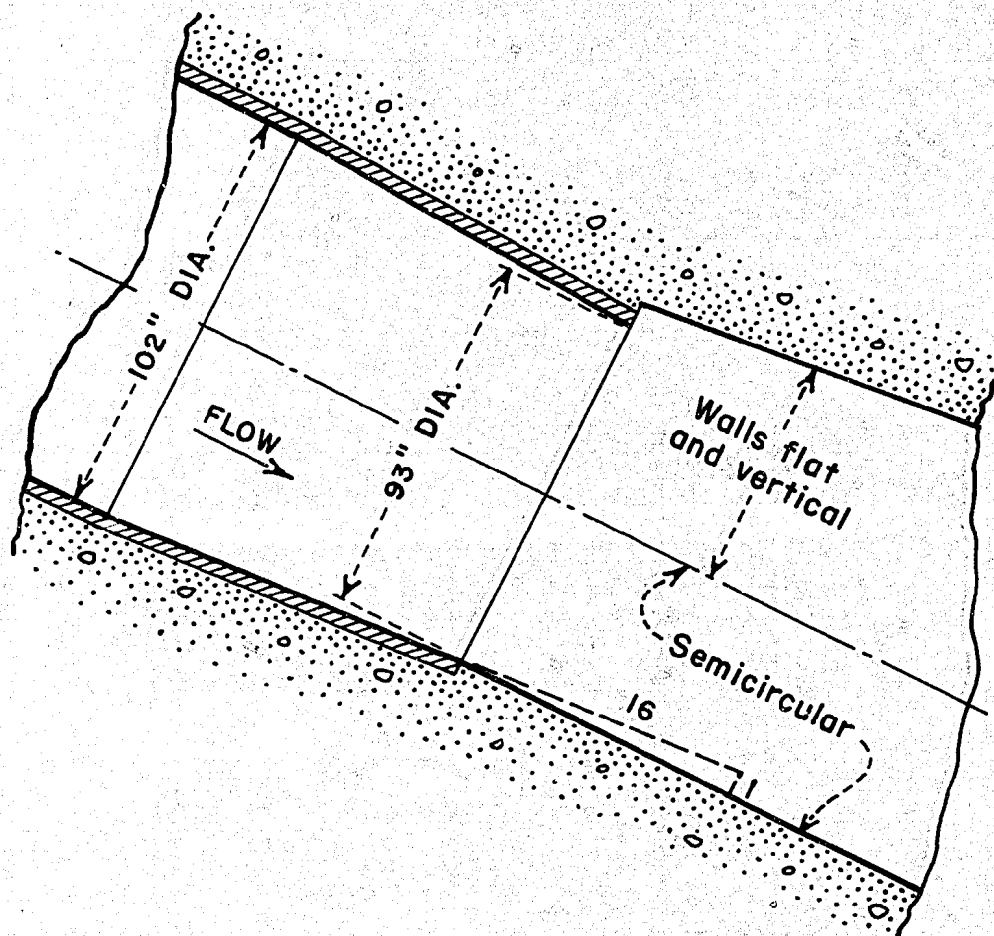
flow surfaces of highhead structures was realized only in recent years. An example of an irregularity designed in a surface some 22 years ago is the exit cone and trough in the upper and intermediate tiers of outlets at Grand Coulee Dam (Figure 8). The abrupt change in alignment of the surfaces, at the rate of about 1 in 16, occurs where the surface of the exit trough continues beyond the cone. This forms an irregularity similar to that shown in Figure 1D. Progressive cavitation-erosion resulted from this irregularity when the outlets recently were operated for flood control purposes (Figure 9). The damage varied widely for the 40 outlets due to various lengths of operating periods, differences in head, local bulges in concrete surfaces, offsets into and away from the flow, and various roughnesses in the concrete. Figure 10 shows the general pattern of early-stage erosion below the cone in one of the conduits.

FIGURE 8. FLOW SURFACE IRREGULARITY
GRAND COULEE DAM OUTLETS

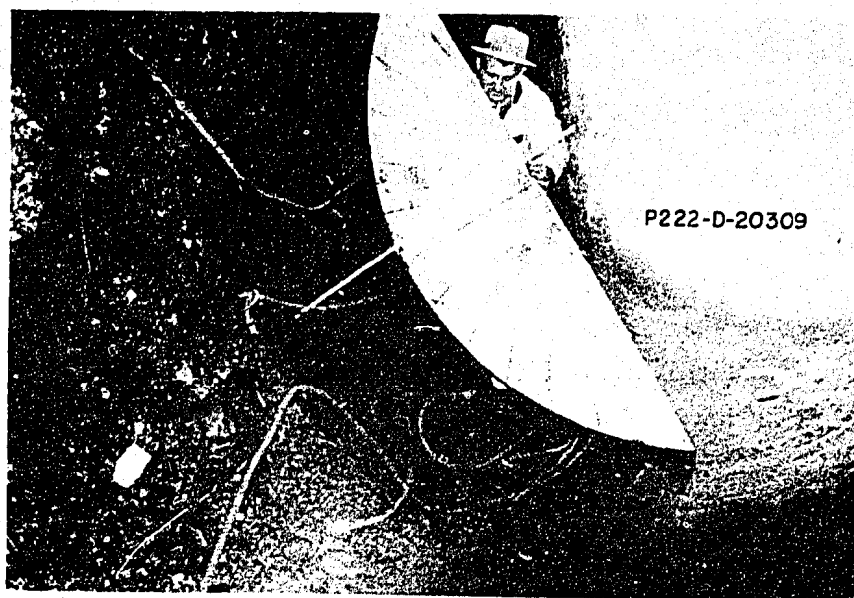
Figure 9--Severe cavitation-erosion in concrete exit trough downstream from liner cone--Grand Coulee Dam Outlet.

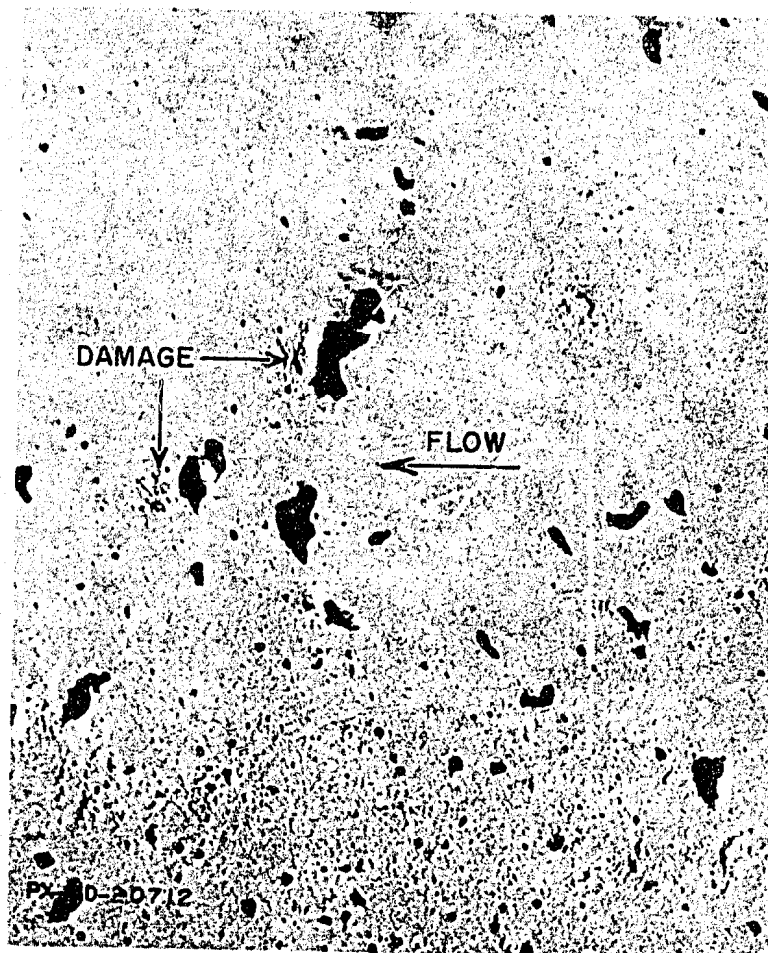
Transverse grooves (Figure 1E), including gate slots, can be a source of much trouble. In this type of irregularity, the low pressure zone forms just downstream from the downstream corner (Figure 2E). A section through a void or "bug hole" is similar to that of a transverse groove. Damage by cavitation has been observed downstream from bug holes of about 1/2-inch diameter and larger (Figure 11). On this basis it is believed that bug holes and voids should be filled to form smooth continuous surfaces when flow velocities exceed about 50 feet per second. The hole depth and width, and the flow velocity will influence the cavitation potential of such irregularities. To date, there have been insufficient observations to establish any definite relationships. Some work on gate slots has been done in the laboratory ^{2/}, but considerable field data covering a wide range of the variables would be extremely useful.

Figure 11--Cavitation-erosion downstream from "bug holes" in concrete. Velocity about 100 feet per second, pressure about atmospheric.
